# SAFETY ALERT #41

October 4, 2010

## **WATER & ELECTRICITY = FIRE BUT NO INJURIES** (this time!)

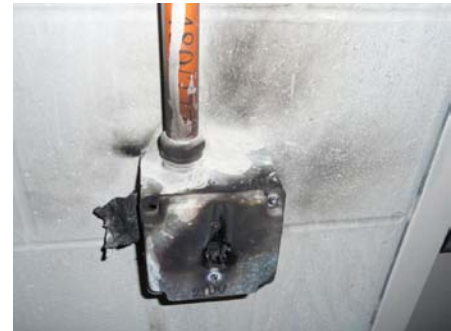
On April 21, 2010 two core drilling employees were drilling above a light switch when water permeated the 277-volt electrical device box causing the switch to trip creating a small electrical fire. Visqueen was used to protect the switch from water and slurry, but this method was ineffective.

- THA not reviewed for the area of work. Electricity was not isolated and locked-out at the source.
- Duct putty & duct seal not used in conjunction with visqueen to protect the device box.
- Work was not coordinated with the general contractor, or electrical contractor.

- Prior to performing work, core drillers are to coordinate scope with general or prime contractor.
- The core driller will complete a Task Hazard Analysis for each specific area work is to be performed.
- If working around electricity, work is to be coordinated with the electrical contractor. Electrical switches and boxes are to be locked & tagged-out at the breaker.
- Electrical contractor is to provide recommendations to the core drillers on how they would like the electrical devices protected.
- After core drilling is complete and electricity is still isolated, an electrician is to inspect the electrical device before reenergizing.
