# SAFETY ALERT # 14

July 3rd, 2006

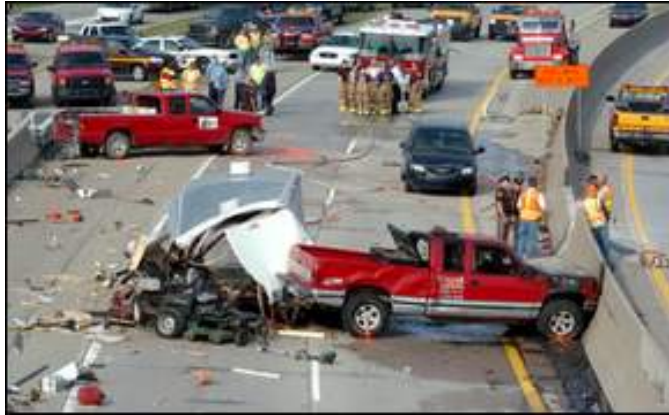
A worker was stepping out of his truck, which was parked on the shoulder of I-94 in Port Huron Township, when he was struck by a vehicle which had lost control. The worker was placing a temporary traffic control device on the shoulder when he was hit. He was wearing a reflective "traffic" vest and had a flashing amber light on this truck. It

was not immediately clear why the driver lost control of his vehicle.

Not to discount the serious injury to the road worker this incident could have been much worse. The truck struck the concrete barrier before being hit by a third vehicle and catching fire. It really drives home the point that anything can happen in the blink of an eye.

It is inadvisable to have a worker on the freeway by him/herself. There should be a second vehicle, preferably with a Truck Mounted Attenuator (TMA), that can be positioned a suitable distance behind the "work" vehicle. There are at least two very good reasons for this. One of course is to block the path of oncoming traffic. The other is to alert motorists to either a problem or construction ahead. Either way this gives the motorists an opportunity to react taking the decision out of the "split second" category.
