SAFETY ALERT # 15

July 7th, 2006

Glazing contractor critically injured when window assembly falls

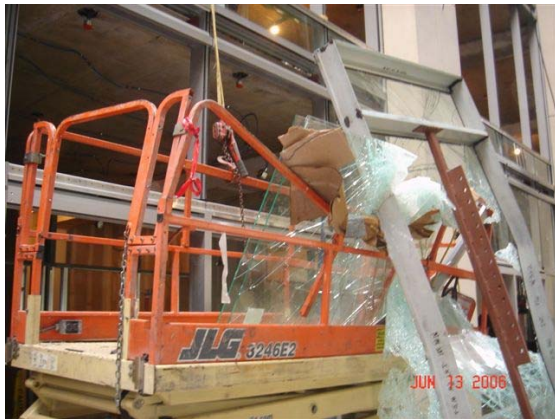
A glazing contractor was adjusting a 4.5'x11' glass panel assembly on the 7th floor of a building. There were two workers (also glazers) in a scissor lift on the first floor directly below the glass assembly.

During the adjustment of the glass assembly, the assembly dislodged and fell down landing in the scissor lift critically injuring one of the workers in the scissor lift below.

- When contractors are working at heights, the area below must be cordoned off to prevent people below from being struck by falling objects.
- Communication among contractors and workers is critical when we have people working from heights. In this case the communication process that was in place was not followed. We might need to be a part of the coordination process to prevent workers from being below other workers.

- The procedure for installation and adjustments for the glass assembly was not followed as it called for the “manipulator” to be hooked up to the glass assembly until the installation was complete.

- Typically, there should be a spotter on the ground to prevent people from being below the overhead work. In this case there was no spotter.
- A Job Hazard Analysis should have been completed. This process helps us to analyze the task, identify the hazard and determine the control or precautions necessary to perform the task safely.

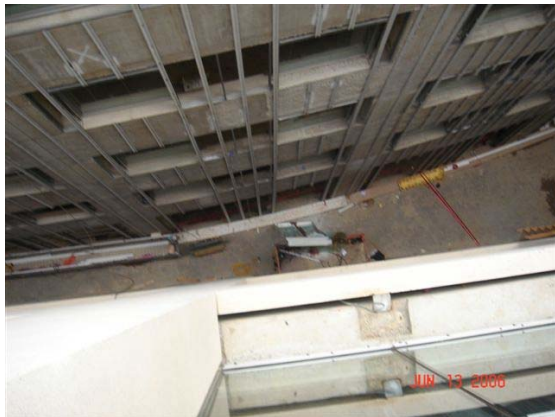
Previously the contractor working above had communicated with the other contractors below. Because they were just "making adjustments" to the window assembly they felt that they did not need to communicate to the crew below. The assembly was installed using a manipulator (crane), however since the workers did not expect the unit to fall the manipulator was not used.
