SAFETY ALERT # 22

FATAL FALL FROM ARTICULATING AERIAL LIFT

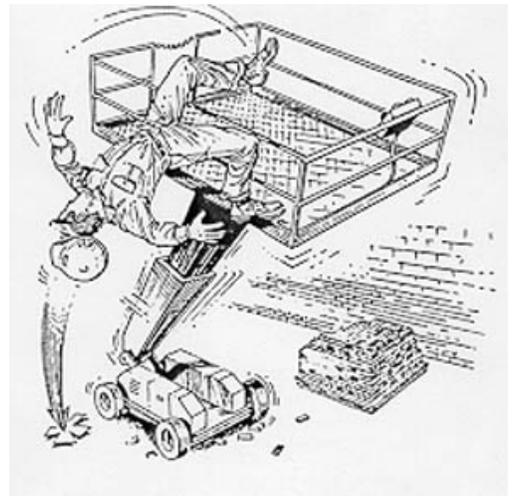
The employee was operating an aerial lift, with an extendable boom rotating aerial work platform. He was thrown from the basket while moving the machine. The boom was fully extended and the machine apparently ran over some bricks, causing the boom to flex or spring, throwing the employee from the basket. The fall was about 37 feet to a concrete surface. The employee died from severe head and chest injuries.

1. Have a competent person conduct frequent regular inspections of the worksite.
2. Permit only those employees qualified by training to operate equipment and machinery. MIOSHA Rule: 3207(1)
3. Instruct each employee in the recognition and avoidance of unsafe conditions and the regulations applicable to his or her work environment.
4. Require the wearing of a body harness and lanyard at all times while in this type of device, in accordance with MIOSHA Rule: 3209(11)
5. Belting off to an adjacent pole, structure, or equipment while working from an aerial work platform is prohibited. MIOSHA Rule: 3209(13)
6. Before moving the lift the operator must make sure that the path of travel is free of obstructions and other hazards. MIOSHA Rule: 3209(27)
